Special Investigation Report
Aircraft Separation Incidents at Hartsfield
Atlanta International Airport, Atlanta, Georgia
October 7, 1980

SPECIAL INVESTIGATION REPORT

**AIRCRAFT SEPARATION INCIDENTS
AT HARTSFIELD ATLANTA INTERNATIONAL AIRPORT
ATLANTA, GEORGIA
OCTOBER 7, 1980**

NTSB-SIR-81-6

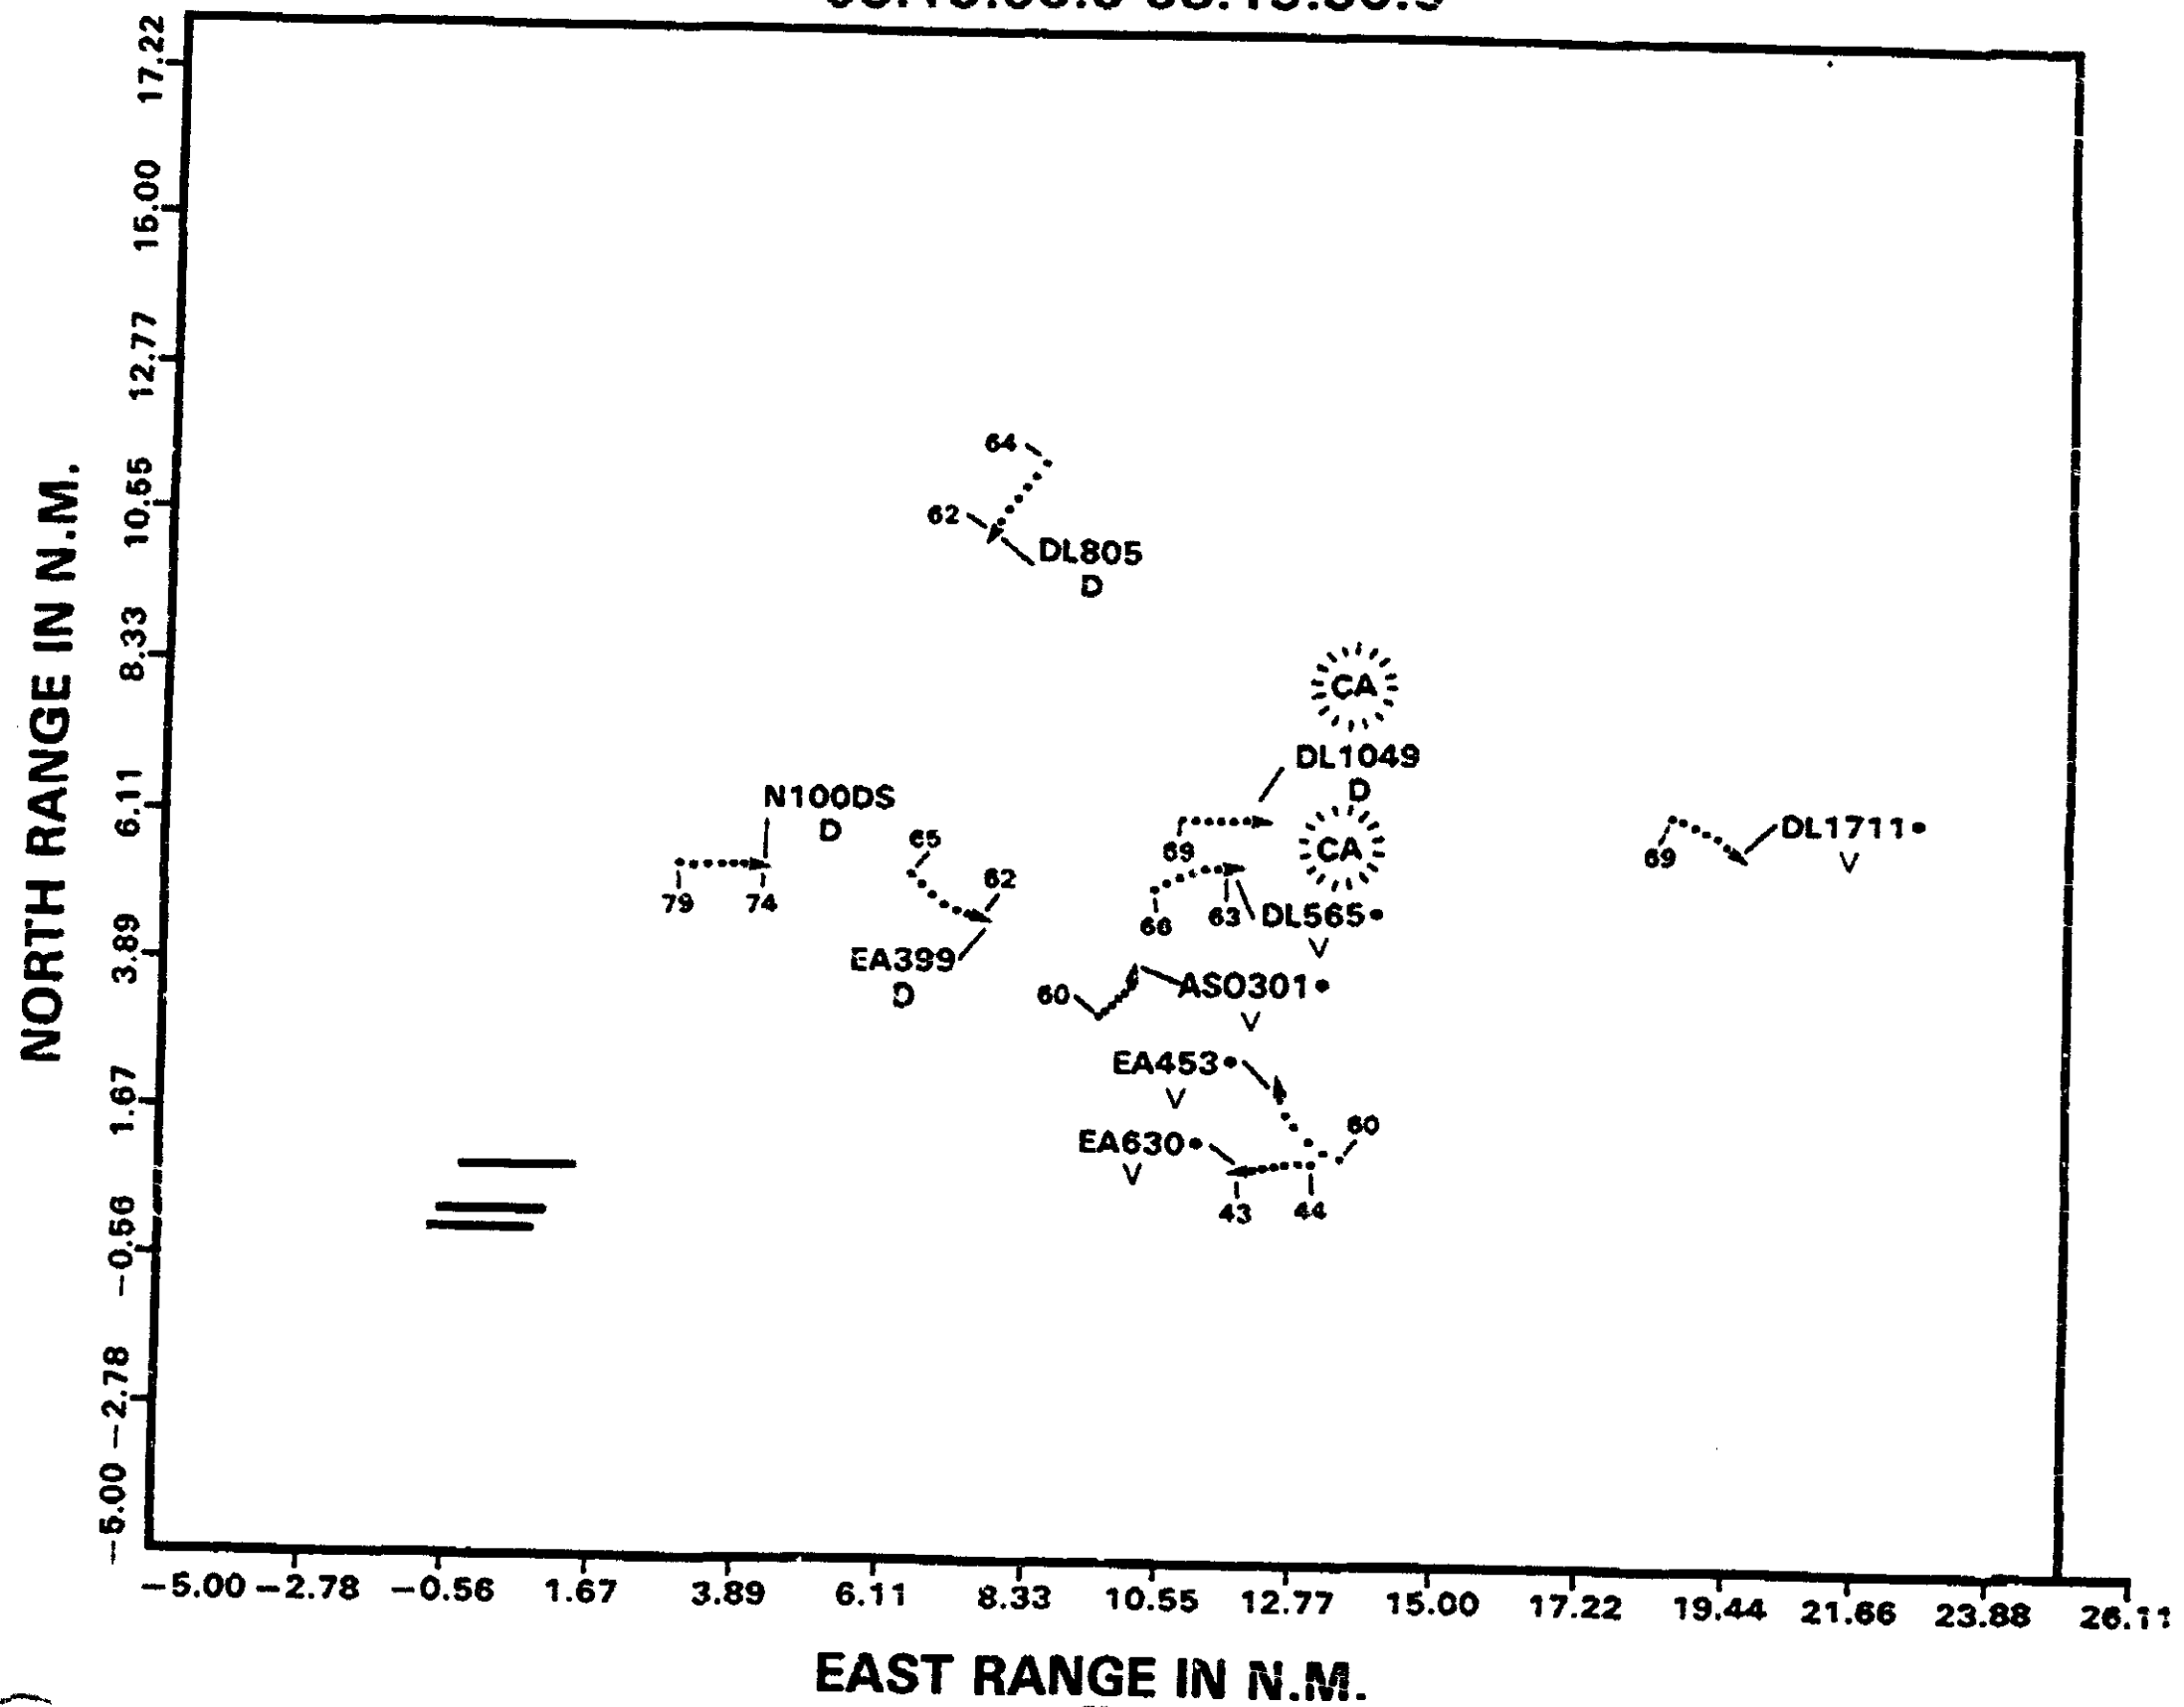
08:19:00.0-08:19:30.0

The data tag for DL1049 on the feeder controller's scope is flashing in the handoff mode with the conflict alert activated. The feeder controller did not recall seeing the conflict alert for DL1049 and DL565. At the end of this 30-sec sequence, separation is increasing. DL565 is leaving 6,100 ft descending to 5,000 ft.
